TECHNICAL COMPLICATIONS OF IMPLANT RESTORATIONS: COMPONENT DEFORMATION, FRACTURE, SEPARATION

Aim To review mechanical irreversible implant restoration complications, and discuss prevention and troubleshooting.

Summary A variety of complications, involving different components are discussed, with clinical presentation, possible causes, prevalence data and accompanying circumstances. Recovery procedures and troubleshooting protocols are also presented.

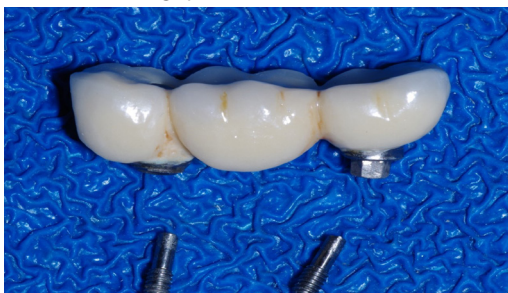
Figure 3. Double screw fracture in implant supported fixed partial denture.

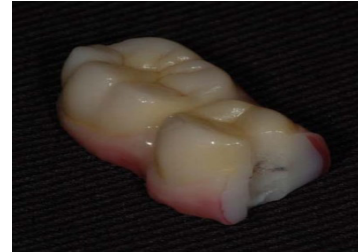
Figure 8. Distal cantilever fracture in full arch zirconia implant supported restoration. Please note that despite the generous amount of material around the screw access orifice, a 17 mm cantilever appeared to produce significant leverage to cause the breakage (Courtesy of Dr. Bryan Limmer, Denver, CO).

Component fracture is a more serious, but less frequent complication that may render recall and future appointments more time and expense intensive. Any component of the assembly can undergo fracture under uncontrolled load and/or as a consequence of poor planning/design. Implant fracture (Fig. 1) is rare - less than 1% at 5 year [4], however, it renders the fixture unusable. Abutment screw fracture (Figs. 2, 3, 4) is relatively rare, at 0.35% at 5 years [5,6], or 3.5% over 15 years [7]. Abutment fracture can occur as an isolated complication (Fig. 5), or associated with a screw fracture (Figs. 6, 7). Abutments with internal connections fail most frequently where the internal connection and the base of the abutment meet. The fractures compromise both the ability of the joint to keep the abutment properly seated on implant and the anti-rotational feature of the system. The fracture of monolithic structures can be catastrophic in full arch restorations and occurs most of the time through a distal screw access orifice (Fig. 8) if a long distal cantilever is designed, with a frequency of 1.4% [8].

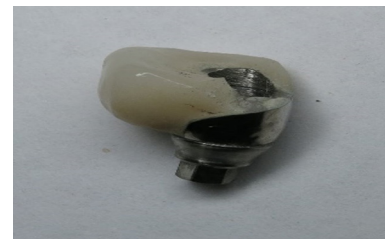
Figure 10. Porcelain fracture at screw access orifice.

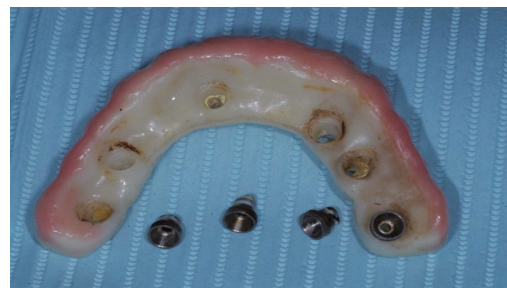
Figure 11. Titanium cylinders' separation from monolithic zirconia full arch implant supported restoration.
